Metcalfe Building Consultants Inc

Inspection Report

Client: New Home Owner Date: 11-12-08 Doc. # 19033-A

Inspection Location: 3456 E Home St Seattle Wa Building Type: One story

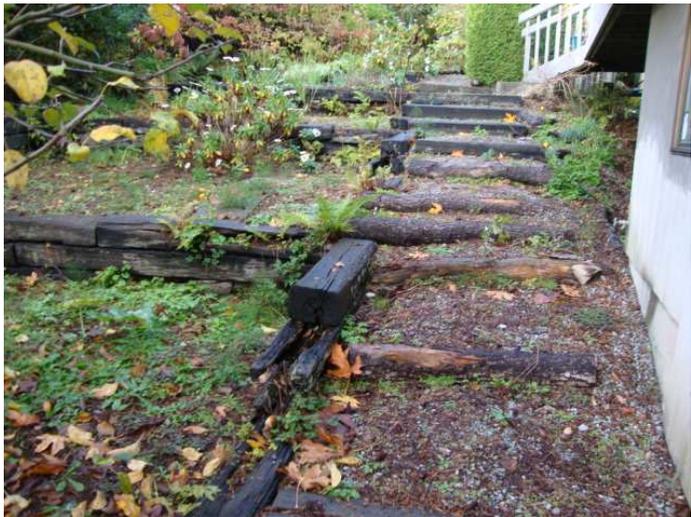
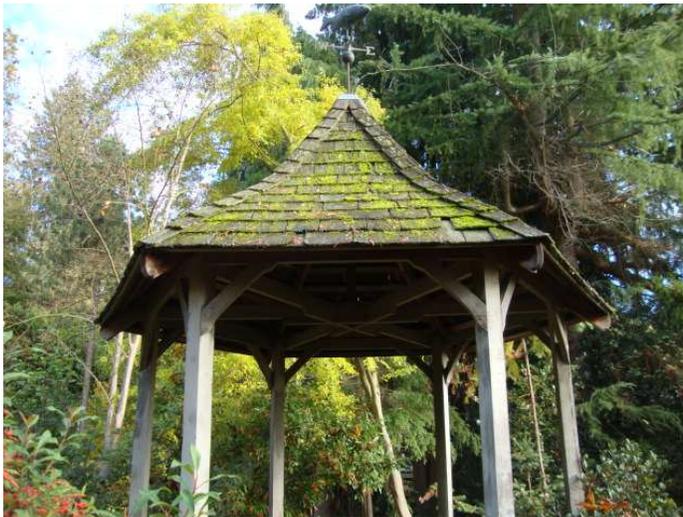
The landscaping timbers on the south section of the building site are deteriorating noticeably. General replacement is needed here.

The small gazebo structure in the backyard is deteriorating.

A narrow strip of the common driveway from the edge of your driveway to the main street has been cut out and patched. This is usually done when water or sewer lines or other utilities have been replaced or added. You may want to ask the current sellers about what was done here.

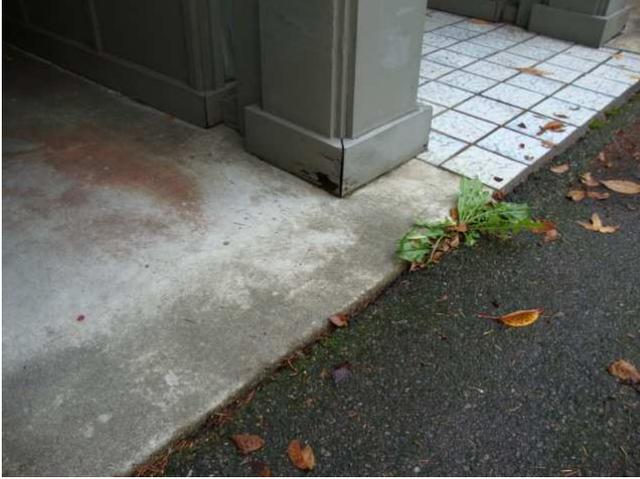
Significant rot is occurring to the siding and trim boards at ground level around the base of the center support columns. The interior flower boxes are also rotting. All damaged wood should be completely removed and replaced.

The electrical outlet on the back wall of the garage should be secured. Ground fault circuit interrupter protection should be provided here for safety purposes.

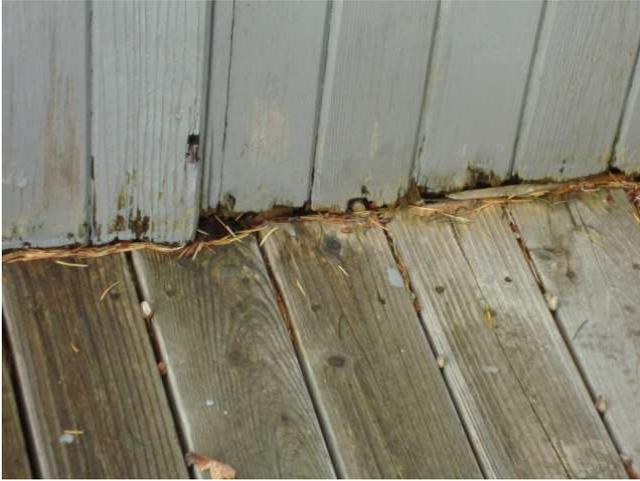
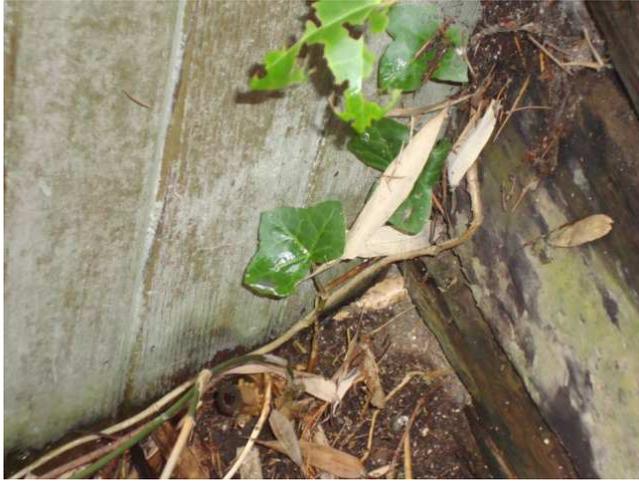
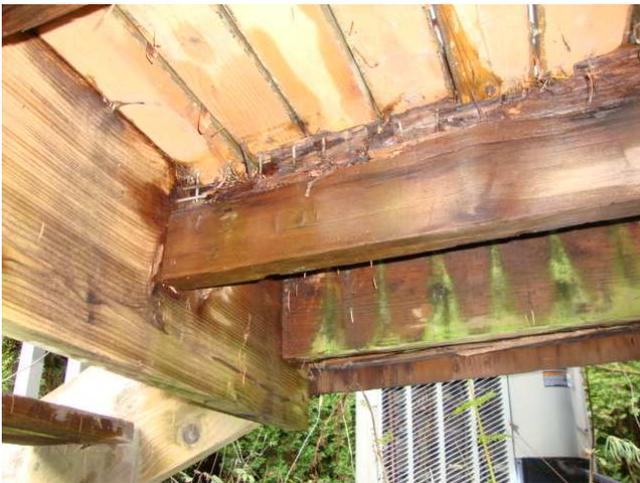
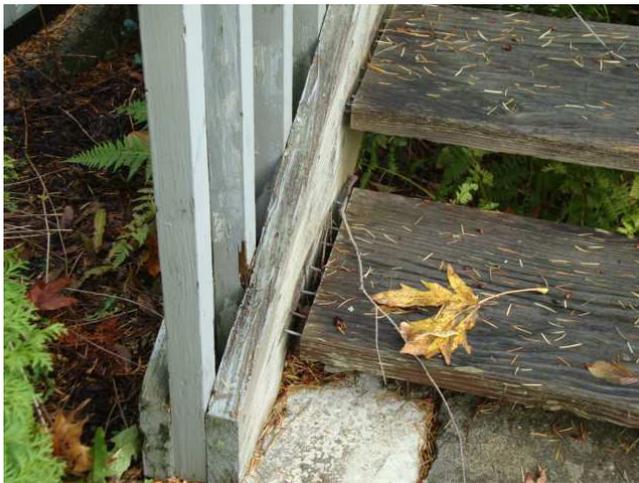
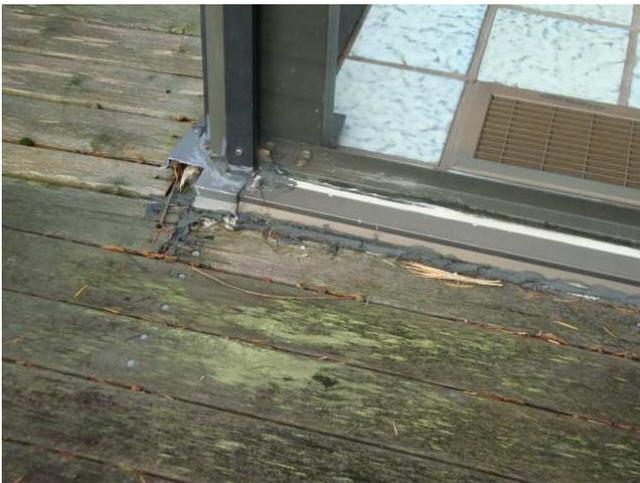
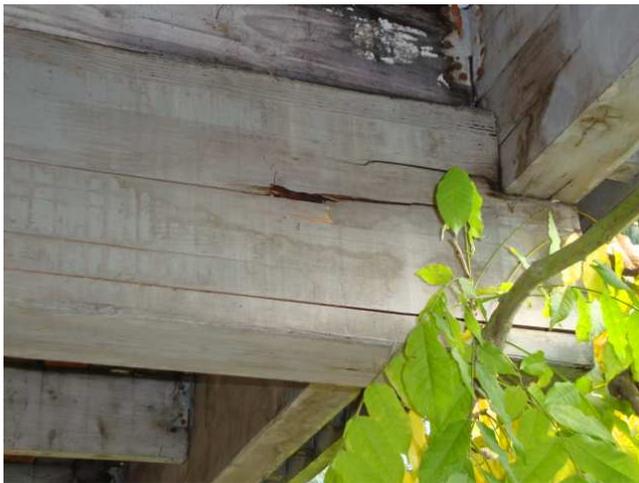
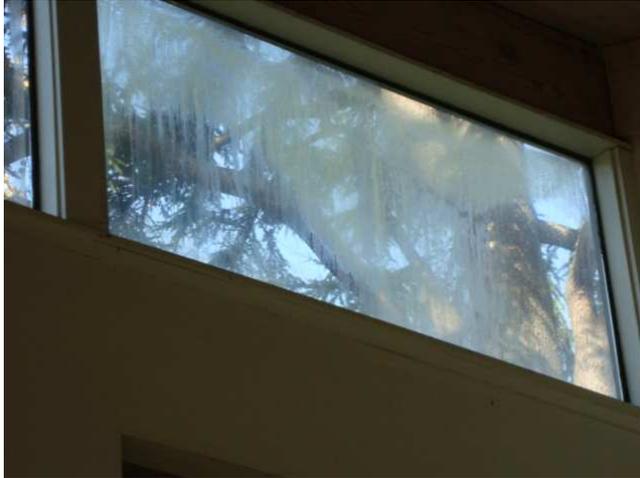
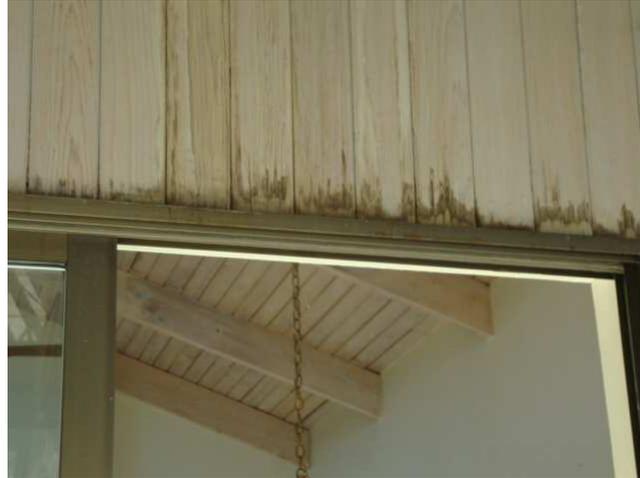
There is earth to wood contact to the siding. This earth to wood contact is occurring on the north, south and front sides of the building. All earth should be kept at least 6" below siding, trim and any other wood members unless the wood is treated wood rated for earth to wood contact. All damaged wood should be removed and replaced with new wood.

Some minor deterioration is occurring to a few of the lower siding boards, where earth to wood contact is not occurring. If siding boards are not kept well sealed, water will wick up into the bottom and grains of the boards and cause deterioration. All damaged wood should be removed and replaced with new wood.

Significant deterioration is occurring to the deck system that extends around the back of the building. This deck system was originally built with non-treated lumber. Some partial repairs have been done but ongoing deterioration is occurring and will continue to occur. General removal and replacement of this deck system is needed now. Because some of the deck support framing is cantilevered, when new support beams are installed, additional support posts and concrete footings will also be needed. Current code requires all decks, stairs and porches to have railings at least 30" high and vertical or horizontal rail members no farther apart than 4" for safety purposes.

The intersections between the walls of the sun room and the deck/tile surface have been sealed with caulk. This area is suspect for potential deterioration. When deck replacement is done, this area should be inspected thoroughly for any ongoing deterioration and repairs should be done as needed. In addition, some water seepage has occurred between the sun room and the main siding of the building.

Rot is occurring to some of the fascia boards and rafter ends behind the gutters. When gutter replacement is done, all damaged wood should be removed and replaced.

Minor deterioration is occurring to a few other trim boards around exterior of the building. In general, all damaged exterior wood siding, trim and framing should be completely removed and replaced. Proper flashing should be installed at all intersections. Appropriate caulking, painting and staining will also be needed.

A significant number of the thermal window seals have failed. All damaged glass sections should be removed and replaced.

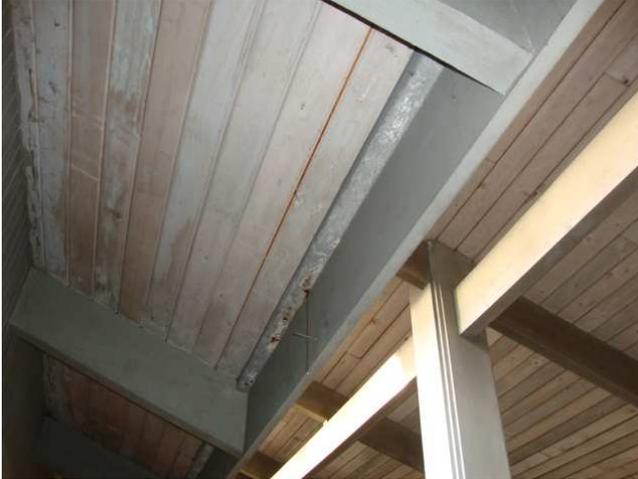
The original galvanized gutters are failing and complete replacement is needed now. Aluminum, copper or plastic products should be installed.

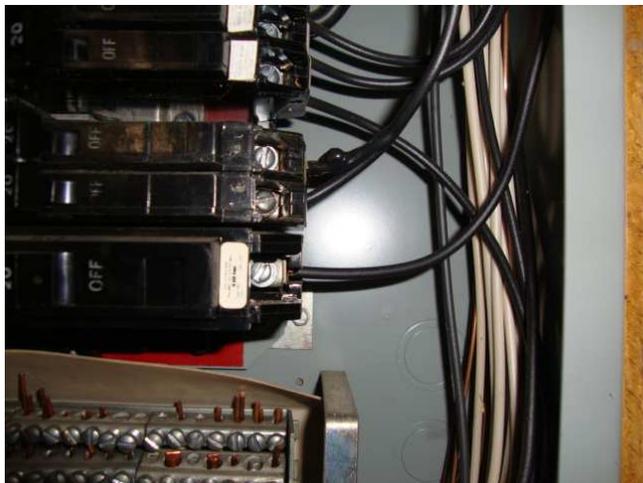
One of the wires in the split-buss panel circuit breaker has overheated. An electrical contractor should be called in now to make all necessary repairs.

The cover plate for the junction box that provides power to the driveway light fixture is missing and should be replaced now.
